The Interstate Building

A major fire severely damaged a twenty-story poured-in-place concrete structure occupied as an office condominium in Honolulu, Hawaii.

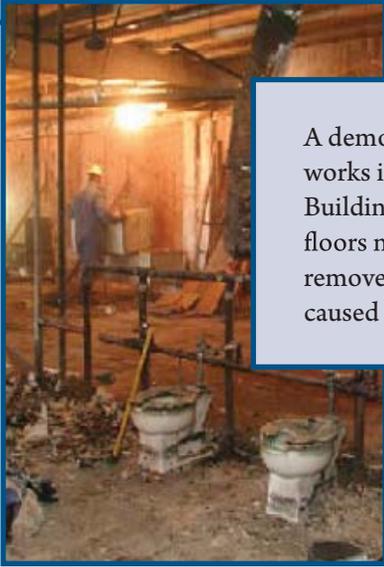
A demolition crewman works in the Interstate Building, where three floors must be gutted to remove mold and fungus caused by water damage.

- Adjusters International introduced an industrial hygienist and assisted in the development of protocol for microbial contamination remediation. Working together we were able to convince the involved parties as to the magnitude of the problem and the need to effectuate the repairs in a two-phase process. The first phase was the emergency stabilization/drying-out process and microbial contamination remediation. Phase I set the stage for a successful Phase II, namely, establishing an accurate scope of damage and specifications for repair.
